Sixth International Conference on Durability of Concrete Structures
18 - 20 July 2018
University of Leeds, Leeds, West Yorkshire, LS2 9JT, United Kingdom

Paper Number TIM16

Damage Evaluation of Full-Scale RC Slab by Ultrasonic Tomography

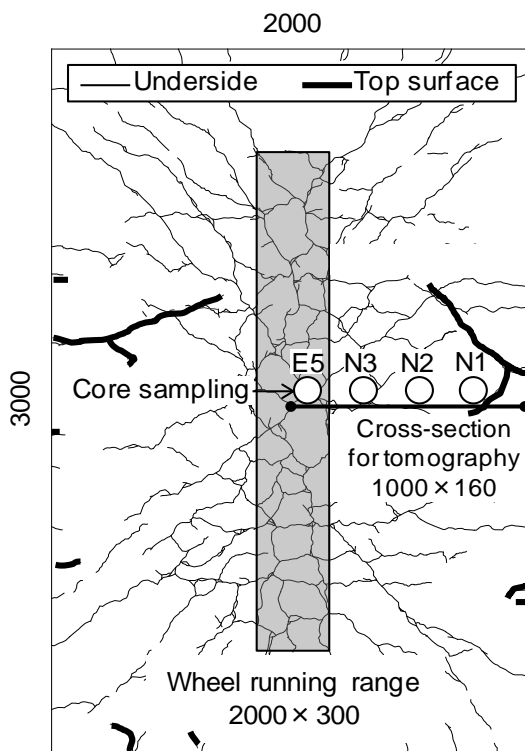
Fig. 3. Cracks in the slab after the wheel running test

In the wheel running test using this running load, the number of runs before the design bending value was attained was 110,000. Cracks in the slab at the end of the wheel running test are shown in Fig. 2. The cracks on the underside are indicated by thin lines, and the cracks on the top surface are indicated by thick lines.

As shown in Fig. 8(d), vertical cracks are seen in the area from the top edge down to about the height of 8 cm. These cracks are observable on the upper surface of the specimen slab, as shown by the thick lines in Fig. 3. These cracks are thought to be generated by negative bending, because Core N1 was close to the supporting point in the wheel loading test. Next, as shown in the top figure of Fig. 7, Region G, which is a region with low velocities in the tomographic analysis, exists on the right side of Core N1. The cracks in Region G may have been generated by negative bending, because they are in the direction of progress of the vertical cracks. Next, regarding the ultrasonic velocity of the core shown in Fig. 8(d), the velocity greatly decreased from the point 7 cm in height to the point 15 cm in height, which seems to correspond to the distribution of the vertical cracks. However, no decrease in velocity that corresponds to the distribution of the vertical cracks is seen in the tomographic analysis shown in the top of Fig. 7. The reason for the above is thought to be as follows. During the wheel running test, the micro cracks opened and closed repeatedly. After the end of the test, the micro cracks closed because the load that opened the cracks was no longer acting on the specimen. Because of the closed micro cracks, the velocity did not decrease around the cracks at the measurement of the ultrasonic propagation velocity of the specimen slab. In the cores, which were used in the measurement of ultrasonic velocity and for fluorescent epoxy resin injection, the micro cracks were open because the confining pressure that had been acting on the specimen was released when the core was taken from the specimen slab. Because of these open cracks in the cores, the velocities in the areas surrounding the cracks decreased and the

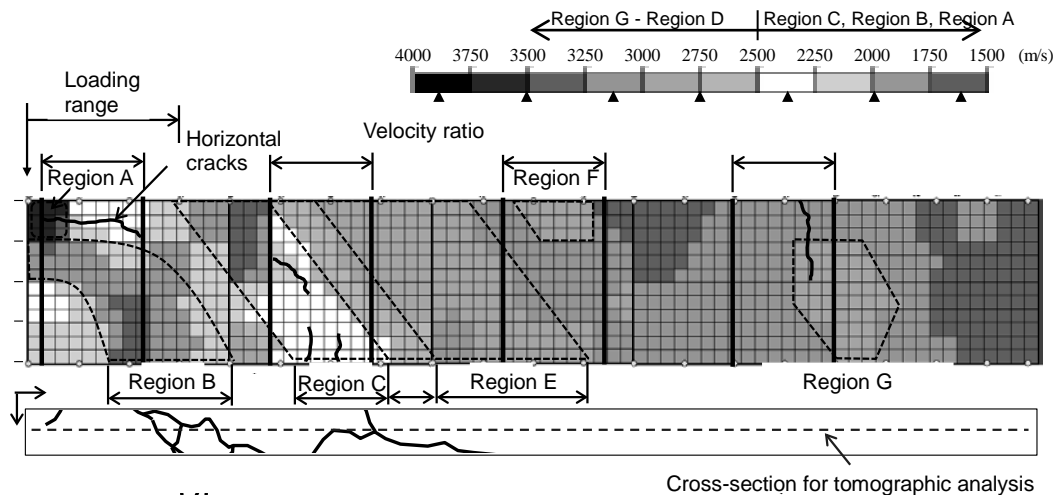
Fig. 7. The results of tomographic analysis of the slab specimen (top) and the conditions of the cracks on the underside (bottom)

In the top of Fig. 7, the ultrasonic velocity calculated for near the horizontal cracks (hereinafter, the velocity) is not constant. The velocity is lower in the left area than in the right area. The reason for the differences in velocity will be discussed in (b).

The velocity for Region A shown in the top figure of Fig. 6 is low relative to the velocities for the regions around it. This region is thought to have received compressive stress and damage because it is near the center of the wheel track and at the upper edge of the specimen. The difference in velocity in the areas near the horizontal cracks is thought to be because damage from compressive stress and damage near the horizontal cracks are mixed in this area. The damage (cracks) from compressive stress are not identified in the Fig. that shows the cracks in the core. It is possible that micro cracks, which are not identifiable by fluorescent epoxy resin injection, occurred. In the other cores, which will be discussed later, the ultrasonic velocity was low; however, micro cracks were not found in the fluorescent epoxy resin injection. Possible reasons for the above are given here; however, the details will be examined in the future studies.

The velocity for Region B shown in the top figure in Fig. 6 is low relative to the velocities for the regions around it. The low velocity found in Region B is thought to be related to the flexural cracks generated by the wheel loading. The reason for the above is as follows. As shown in the bottom figure in Fig. 6, flexural cracks are found in the part of Region B on the bottom surface of the specimen. A previous study (Mihashi *et al.*, 2010) pointed out that micro cracks that were too small to be seen by the naked eye accumulated around the cracks that were generated by tensile stress. In the current study, it is thought that the velocity in Region B was low because of the flexural cracks generated by wheel loading and micro cracks at and around the flexural cracks.

The results of tomographic analysis for the location of Core N3 shown in the top of Fig. 7 shows that the velocity of Region C is low compared to those in the surrounding regions. Region C extends from the edge of the wheel loading range on the top surface of the specimen slab diagonally downward. The cracks discussed in (1) are in Region C. In light of their location and direction, these cracks are thought to appear after micro cracks had developed, accumulated and reached their limit of being micro cracks by punching shear. Based on the above,

Regions D and E, which abut Region C, were found to distribute diagonally and parallel to Region C, which is the region damaged by the punching shear. The velocities in Regions D and E gradually become smaller as one move away from the center of the wheel running track.

As shown in Fig. 8 (c), marked cracks are not found in Core N2. The results of tomographic analysis for the location of Core N2 in the top figure of Fig. 7, in addition to Region E described earlier, show that the velocity of Region F is lower than those in the surrounding regions. Next, the ultrasonic velocities of cores shown in Fig. 8 (c) are examined. The degree of decrease in the ultrasonic velocity is small as a whole; however, the ultrasonic velocity at the locations from the height of 1 cm to 5 cm is low, which corresponds to the velocity in Region E, and the ultrasonic velocity at the location at the height of 15 cm is low, which corresponds to the velocity in Region F. The low velocity in Region F is thought to be from either punching shear damage or compressive stress damage.

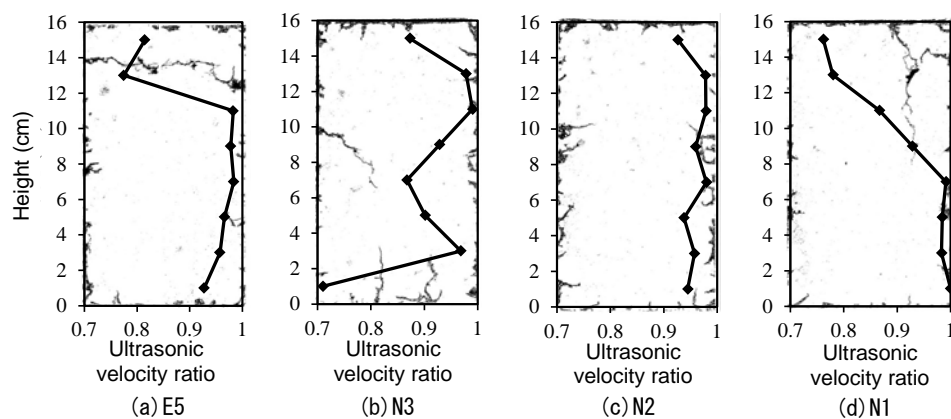
Fig. 8. The conditions of cracks on the cross sections of the cores and the results of ultrasonic velocity measurement

Core E5 is from immediately below the loading range, and as shown in Fig. 8 (a), horizontal cracks were found at heights of about 14 – 12 cm.

As shown in Fig. 8 (a), the ultrasonic velocities at the heights of 15 cm and 13 cm are considerably low. In light of the condition of cracks and the analysis results of tomography, these low velocities are thought to result from damage caused by compressive stress and damage near the horizontal cracks. The degree of lowering in the ultrasonic velocities at the locations from the heights between 11 cm and 1 cm is small; however, the ultrasonic velocities mildly decrease as the waves approach to the lower end of the core. This lowering of ultrasonic velocities is thought to be from the micro cracks discussed in (2) (c).

Core N3 is from near the edge of the loading range where cracks from punching shear are generally thought to occur. As shown in Fig. 8 (b), the existence of diagonal cracks around the heights of 10 – 7 cm and the occurrence of vertical cracks around the heights of 3 – 0 cm are observed.

As shown in Fig. 8 (b), the ultrasonic velocities are very low in areas from the heights of 11 cm to 7 cm and in areas from the heights of 3 cm to 1 cm, both of which are areas with cracks that were discussed in (1). Similar to Core E5, the ultrasonic velocity at the point with a height of 15 cm, which is close to the top edge of the specimen, is much lower than those of other areas.
